# case in point

## UVC approach stops mold, enhances IAQ for medical firm

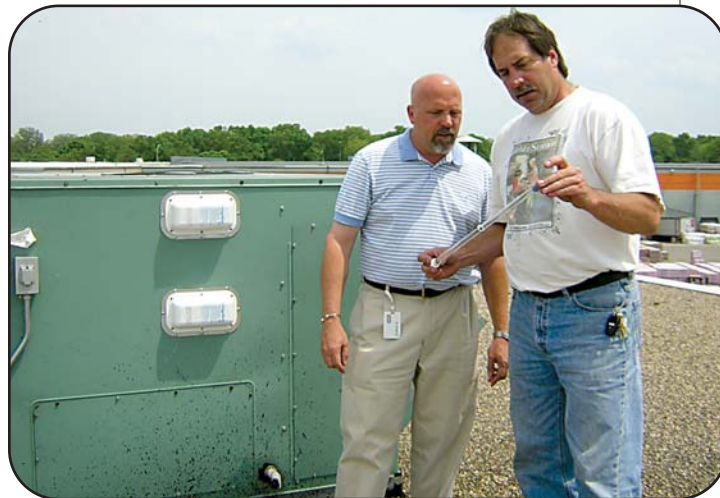
Bruce Strandberg (left) and Randy Remer prepare for annual changeout of the replaceable UVC Emitter™ tubes in the rooftop air handling units.

ing of the building’s air conditioning coil. “The continuous germicidal action of the lamps keeps contaminants from building up on coil surfaces, so chemical cleaning has become unnecessary. We hope to incorporate UVC into new air handlers as we replace them, so that we can enjoy further maintenance savings. We anticipate that the UVC will save energy and possibly increase air handler life as well, since the units won’t have to work as hard,” he noted. The Steril-Aire lamps will require no maintenance other than an annual changeout of the tubes.

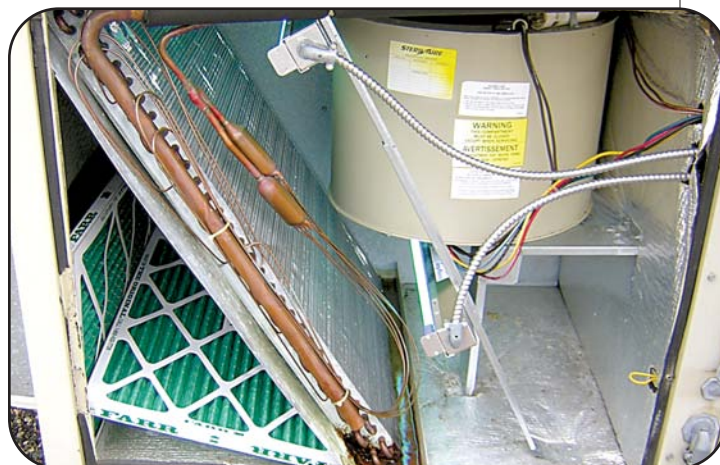
UVC Emitters™ in the air handling units have successfully eliminated both surface mold and airborne mold spores at Medicine Lake Properties.

“Egan Companies has had previous experience with Steril-Aire UVC Emitters in a variety of buildings, where the lights are used to control mold at its source,” Strandberg said. “Installed opposite the cooling coil, the high output UVC lamps kill existing mold in the system and — equally important — prevent mold from growing back. They also stop mold-related allergens, bacteria, and viruses from spreading through the occupied space via the air-handling system, further improving IAQ,” he noted.

In mid-2004, Egan installed Steril-Aire’s multi-patented UVC Emitters in the two air handlers serving the medical office suite. Prior to installation, Strandberg took microbial Petri dish samples from the coil surfaces to measure the level of mold contamination. Approximately a month later, follow-up samples showed a dramatic decline in mold levels.
